# **Appendix D**

## **Anomaly, Failure and Mishap Reporting**

## D.2 Significant Events

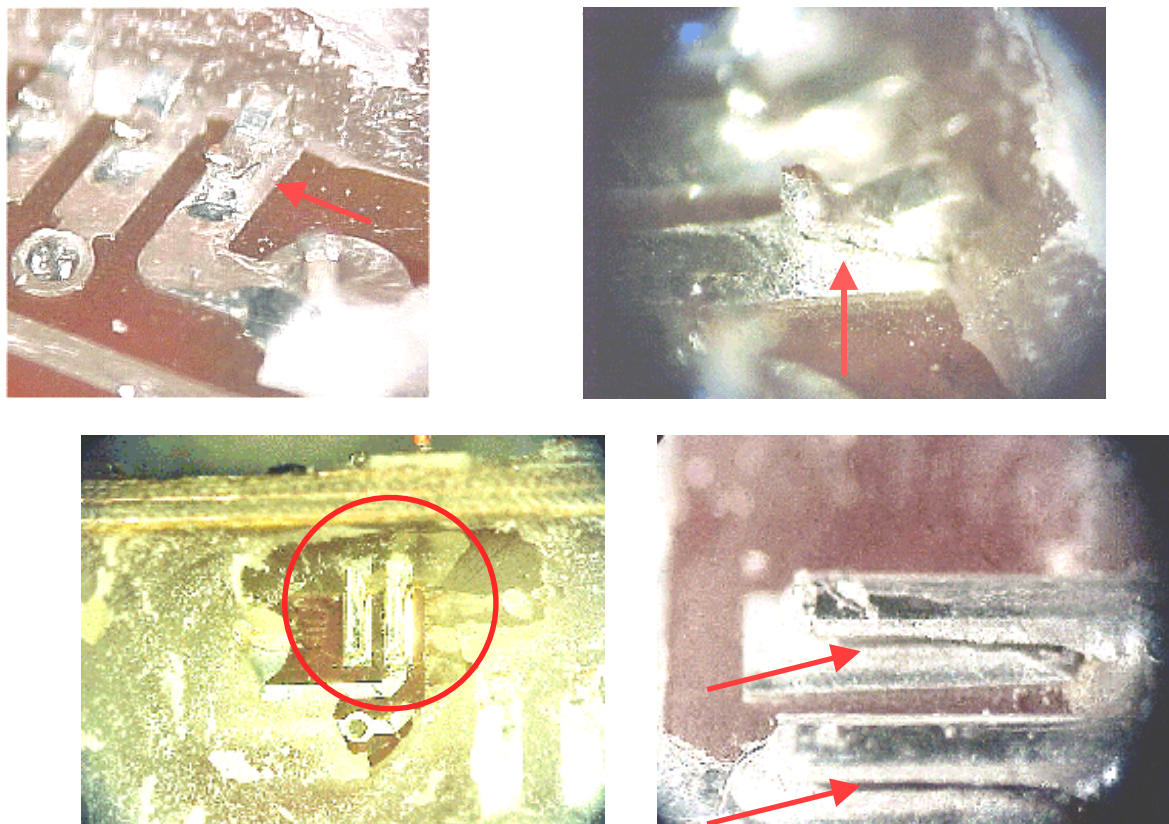
To investigate the problem, the TOF *brick* was dismantled and the Linear Regulators were carefully inspected. As a result, some of the SMD soldering of the straight pins were found to be broken, as shown in figure 3. According to CAEN, the failures were due to different thermal coefficient between resin and soldering material, generating a stress able to cause the connection rupture.

Figure 3 – Pictures of the pads where the *fork pins* were soldered.

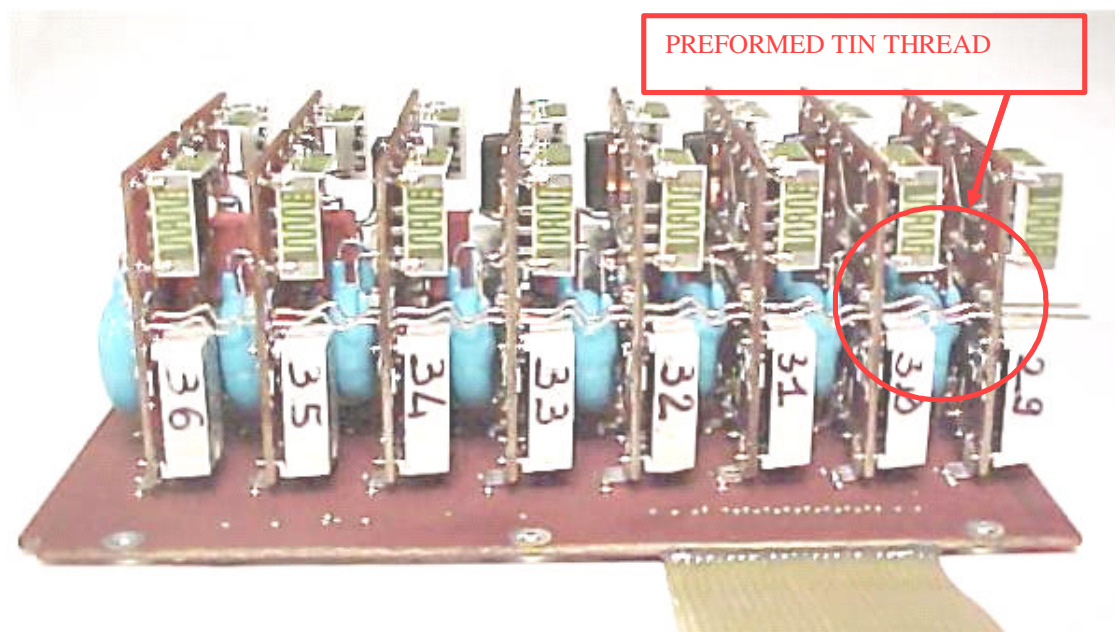
Figure 5

– QM2 test board. Also the interconnection thread has been preformed.

**Corrective Action:** The straight forked pins interconnecting between the 16 mini-boards were replaced in a test configuration and qualification unit 2 with reshaped pins that provide a strain relief function that the straight pins could not provide. A test board has been constructed and tested at CAEN as follows: 1) burn-in for 8 hours with a temperature of 70°C ; 2) thermo-vacuum test with pressure of 0.1mBar, verifying the absence of discharges ; 3) thermal cycles (10 cycles in total between -30 °C and +70 °C, with a ramp-up rate of 4 °C /min, down-ramp rate of 2 °C /min and time of permanence at each temperature of 1 hour). At the end of each cycle, all the channels were inspected. No problem was observed.

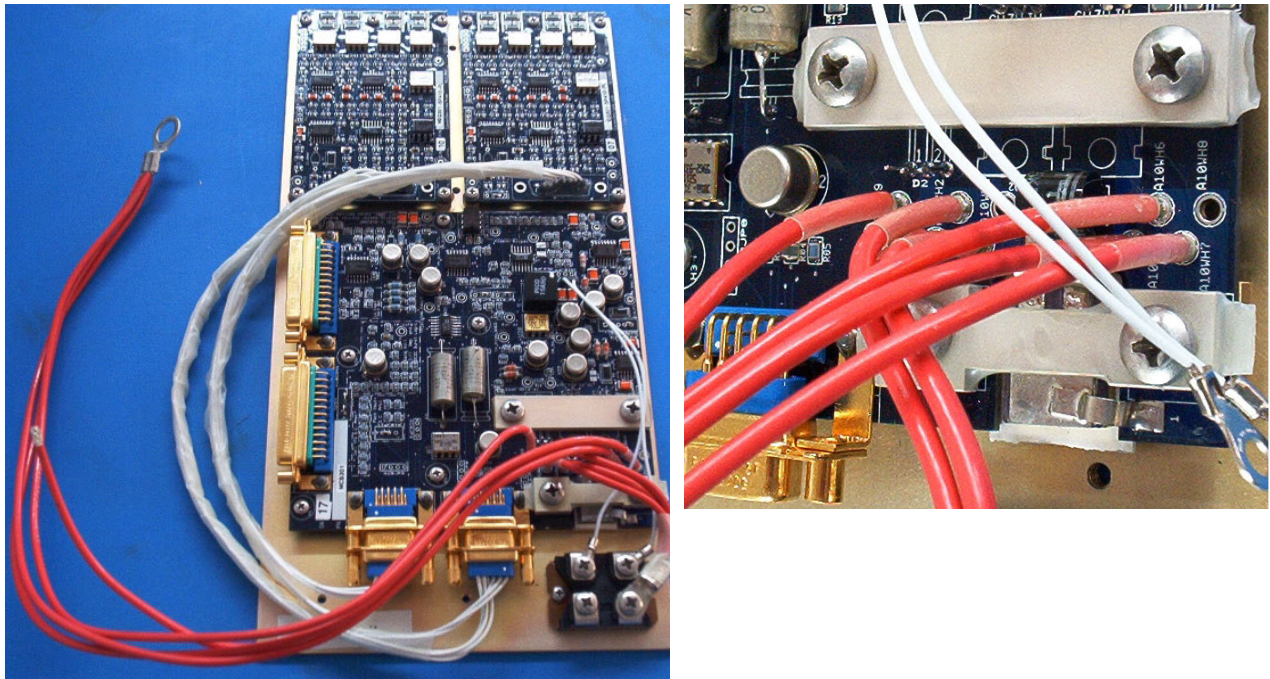
**Description of Event:** During the final system testing of the full electronics assembly at Eaves Devices, the last board (5<sup>th</sup> out of 5) tested failed the current interruption test (support 77A for 360ms to 1500ms). Upon examination of the board, it was discovered that the FET was cracked under the compression bar holding it in contact with the heat sink. These cracks apparently shorted the device, causing it to fail under high current. As shown in the attached pictures, the FET (located in the front right of the AMS BMS picture, near all the big red wires) has a compression bar over the top of it, holding it in contact with two layers of SIL-PAD and an aluminum heat sink. Per Eaves Devices assembly procedures, the screws on this compression bar are only torqued to 6 in-lbs.

Further examination of the other 4 boards revealed that the FETs in those boards showed signs of cracking, but had not failed any testing.

**Corrective Action:** Compression bar was eliminated from the design and a thermally conductive adhesive was used. Material usage was approved by JSC Materials. Thermal performance and board function were retested and found acceptable.

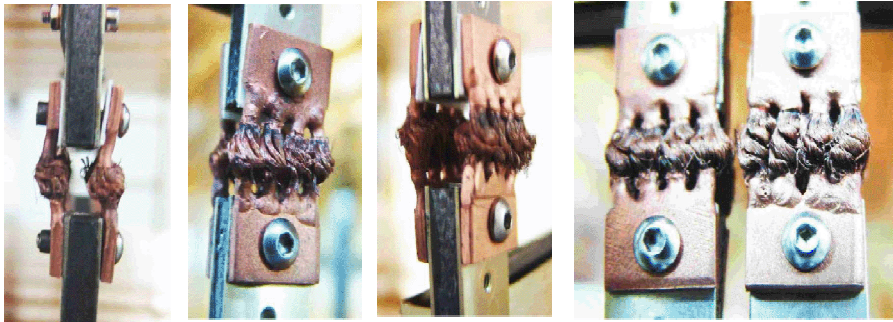
This compression was performed *in situ* during assembly of the 3 planes of the inner tracker but before the definitive connexion. Some braids were damaged:

- Some weakness of the metal properties might have been introduced by the welding of the Copper braids
- The effect on thermal conductivity is negligible.
- The damaged threads showed a single break.
- No one was found to be loose.

**Corrective Action:** Heat shrink tubing implemented over braids to contain any possible fragments. Fragment generation unlikely as copper conductors were only broken on one side and still retained on the other. Additional containment within tracker is provided by mesh filters at light tight vents.

**Actions taken:** Study of a containment procedure of the Copper braids using space qualified heat shrink tubing (*See Appendix B*). This tubing must be installed *in situ* after vacuum cleaning of the braids with examination of the filter. The heating should not damage the electronics.

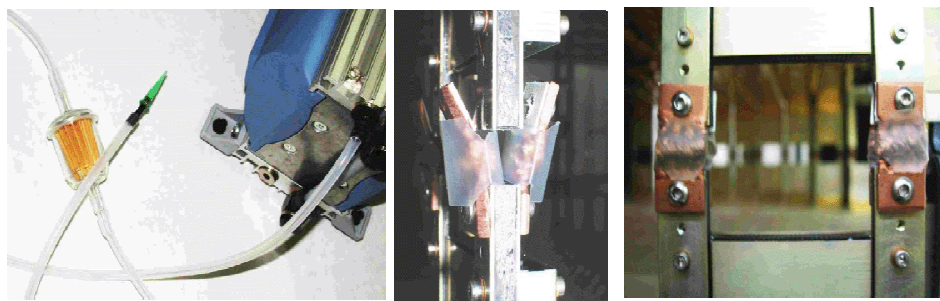
A procedure was established and was applied on all thermal connectors. A preliminary cleaning was made with a micro vacuum cleaner. The filter was examined. No broken thread was found in the filter.

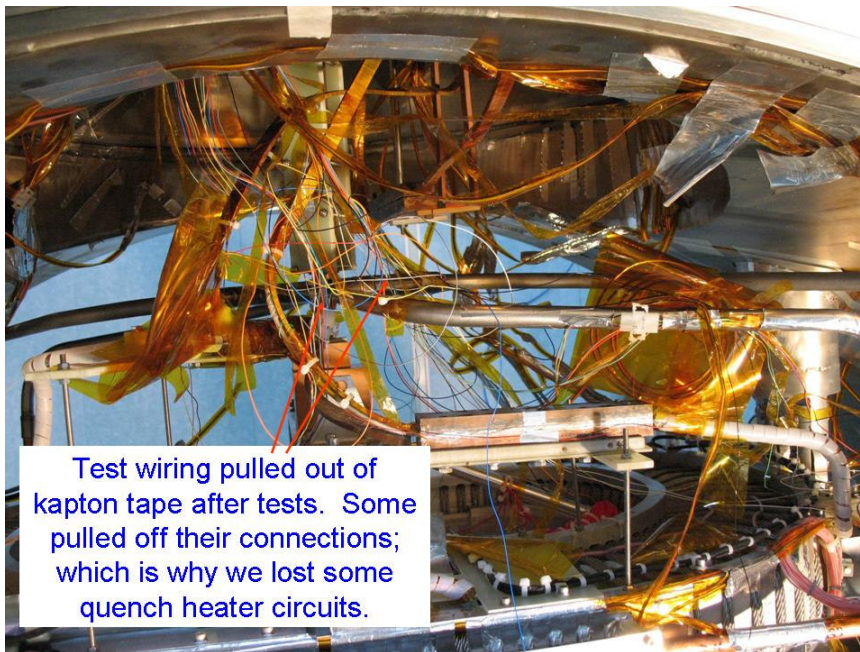
Figure 3: Test Wiring After Magnet Testing

**Description of Event:** Prior to completing the assembly of the AMS Superconducting magnet, the magnet assembly was tested in a Magnet Assembly Test Rig. During this testing, several Special Test Equipment heaters were added to the magnet. These heaters were used to intentionally induce a quench in the magnet coils. Essentially, they were put in place to mimic the flight quench protection heaters or a random quench. The wiring for these heaters, which was also STE, was not adequately held in place to prevent movement during a quench. Essentially, the wires were bundled together with Kapton tape only (Figures 1 and 2). At the operating temperature of 1.8 Kelvin, the adhesive on the Kapton tape was not adequate to hold the wires together. During a magnet quench several of the wires experienced loads induced by the rapidly changing magnetic fields. These loads moved and pulled some of these wires out of the STE circuit board or the heater (Figure 3). The result of this was that several of the test necessary heaters to ensure no damage is done to the magnet were not functioning and the test had to be abandoned.

**Corrective Action:** Flight systems were not directly impacted by this event, however actions were taken to assure that all wiring for the flight system has adequate restraints to prevent movement and pull-out of necessary electronic equipment and wiring.

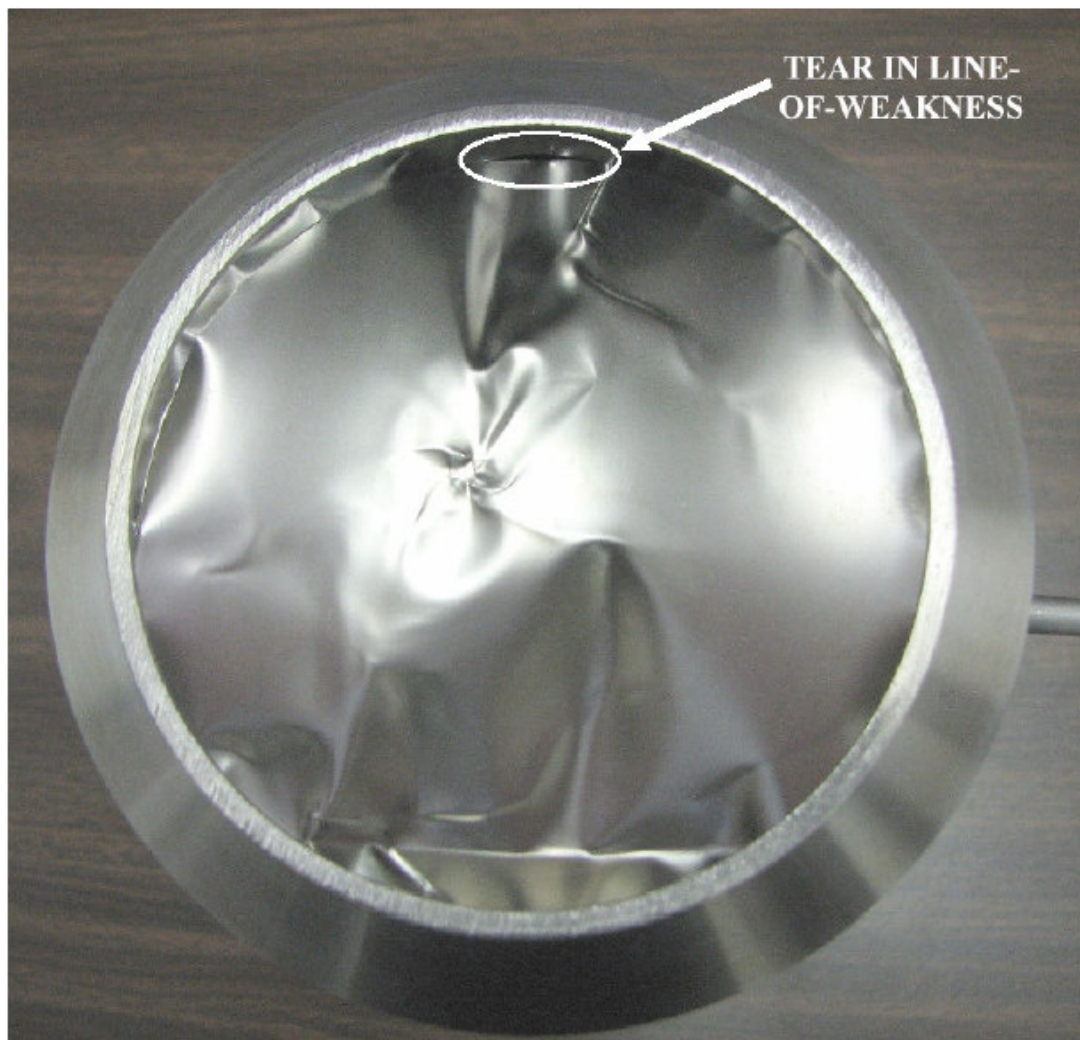
**Figure 4: Incomplete Tear of BD07B**

In the qualification burst of Units 1-4, BD07A ruptured normally, but BD07B failed to fully open. The disk membrane appeared to reverse, but did not fully tear. (This was confirmed when Unit 1 was cut open for a visual inspection of the disk, shown in Figure 4.) Airflow through BD07B was restricted enough that all air passing through simply vented through the interspace vent line. Air flow into the test volume was shut off at the sound of the event, preventing a renewed pressure rise.

In addition to these tests, Units 1 and 4 were tested a second time to see if the second disk would eventually rupture nominally if repressurized to the design burst. In both cases, BD07C burst normally, but BD07B remained in the partially torn condition.

The anomalous test results clearly require a change in the overall design of this assembly, but because of the advanced stage of payload manufacturing and design, the goal is make the modifications as simple as possible. The project's proposal is to remove BD07A from all remaining assemblies using a similar process to what was done for Unit 5. The vent line for the BD07A/B interspace would be crimped and welded shut as well. The flight system would then look exactly like Unit 5, which has undergone a successful qualification test. Units 6 and 7 would also undergo qualification bursts to give the 3:1 test ratio mandated in the burst disk verification plan. The new schematic is shown in Figure 6.

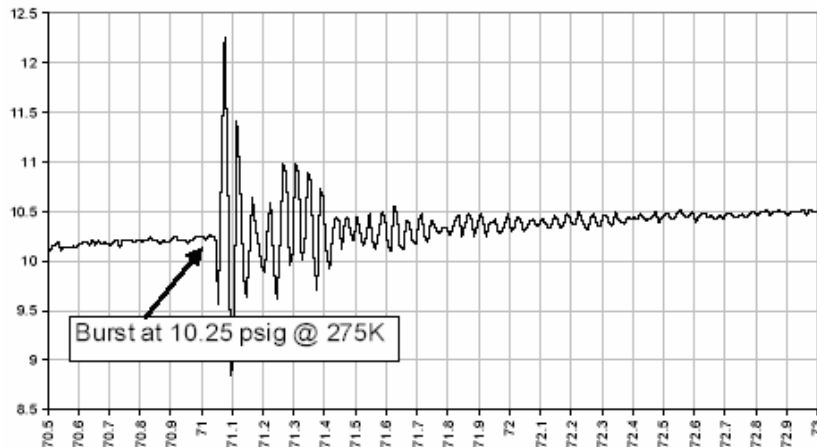
Figure 5: Pressure v. Time for Unit 4 Qualification Test

During the test of Unit 4, pressure taps recorded data at the inlet of BD07A and the interspace between BD07B and BD07C. The pressure data for the BD07A inlet is shown in Figure 5. Immediately after burst, there is a series of wide pressure oscillations ranging over nearly 3 psig at approximately 20 Hz. The cause of this oscillation is not immediately clear, but it is the likely cause of the anomalous behavior. The first spike at 12 psig is more than enough to reverse disk BD07B, but since it drops to less than 9 psig within approximately 0.05 seconds, there may not be enough energy to completely tear the disk along the score line. (The pressure measurements in the BD07B/C interspace did not show these oscillations.)

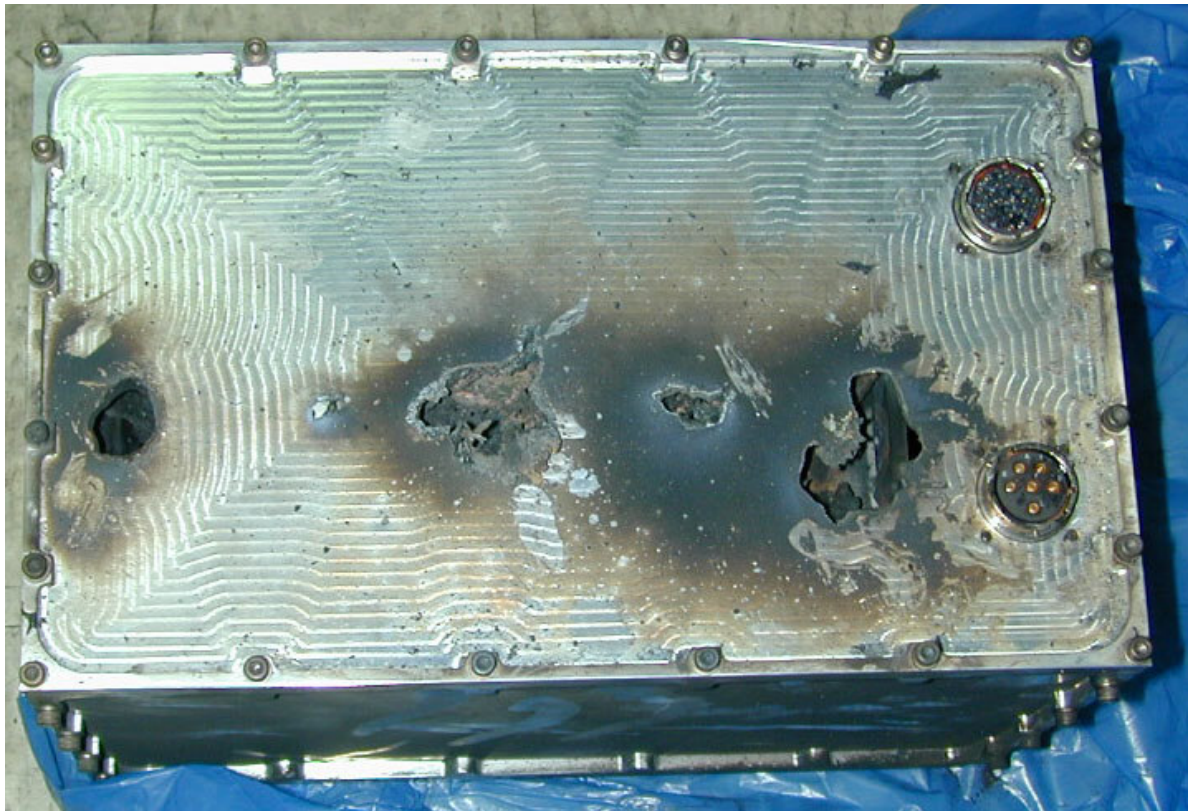
Figure 11.1 – Engineering Development Unit (EDU) UPS after fire event.

During testing, November 2006, of the AMS-02 Uninterruptible Power Supply (UPS) Engineering Development Unit at CSIST (Chung-shan Institute of Science and Technology) the battery assembly experienced a thermal runaway that resulted in a aggressive fire event that destroyed the UPS assembly.

**Corrective Action:** Upon review of the SYSU test set up and procedures, it was established that the charging system had not implemented the required controls to limit current or monitor battery performance that would have been enacted to compensate for the cell failure observed. Also at the time of the testing event, the testing engineers were absent. All remaining UPS units were returned to Yardney, the manufacturer of the cells and testing resumed at that location. See AMS-02-A12 for performance issues with remaining UPSs.

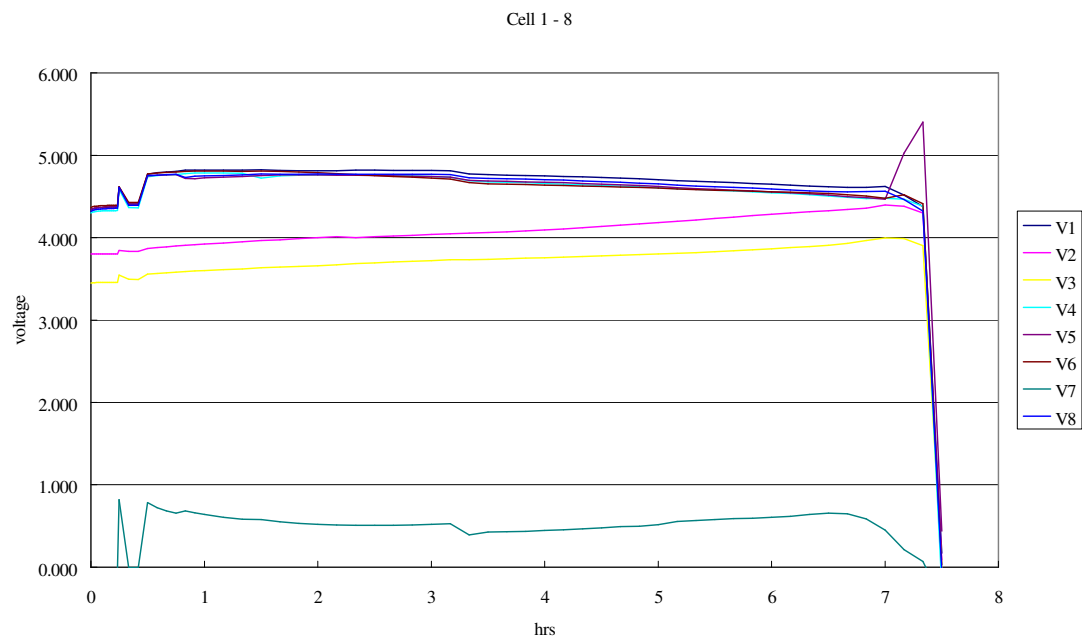
Graph 5: Voltage of Cell 1 to Cell 8

7. Unfortunately, only individual cell data of Graph 4 (attached) was taken by Digital Recorder (Accuracy is  $\pm 0.01\%$  of reading) due to restriction of the Recorder memory. Voltages of Cell 1 to Cell 8 are cited in Graph 5. At 15:53:02, voltage of Cell # 7 is -0.136 V and voltages of Cell # 2/#3 are 3.801/3.450 V. The battery was not well balanced after 1<sup>st</sup> charge/discharge/charge cycle. Voltage of Cell # 7 was below 1 volt during the Constant Voltage charging period. Voltages of the health Cells #1/4/5/6/8 are above 4.67 V at 16:41:04.
8. At 23:22:58 Voltage of Cell #5 was 5.011 V. At 23:27:14 Voltage of Cell #5 was 5.850 V.
9. At 23:35:28, V5 dropped from 5.521 to -0.077 V; V3 dropped from 3.899 to 0.479 V; V7 dropped from 0.067 to -1.070 V.
10. At 23:43:08 all cells went to zero or negative volts and the temperature at cell #5 was 1759.0 deg. C.

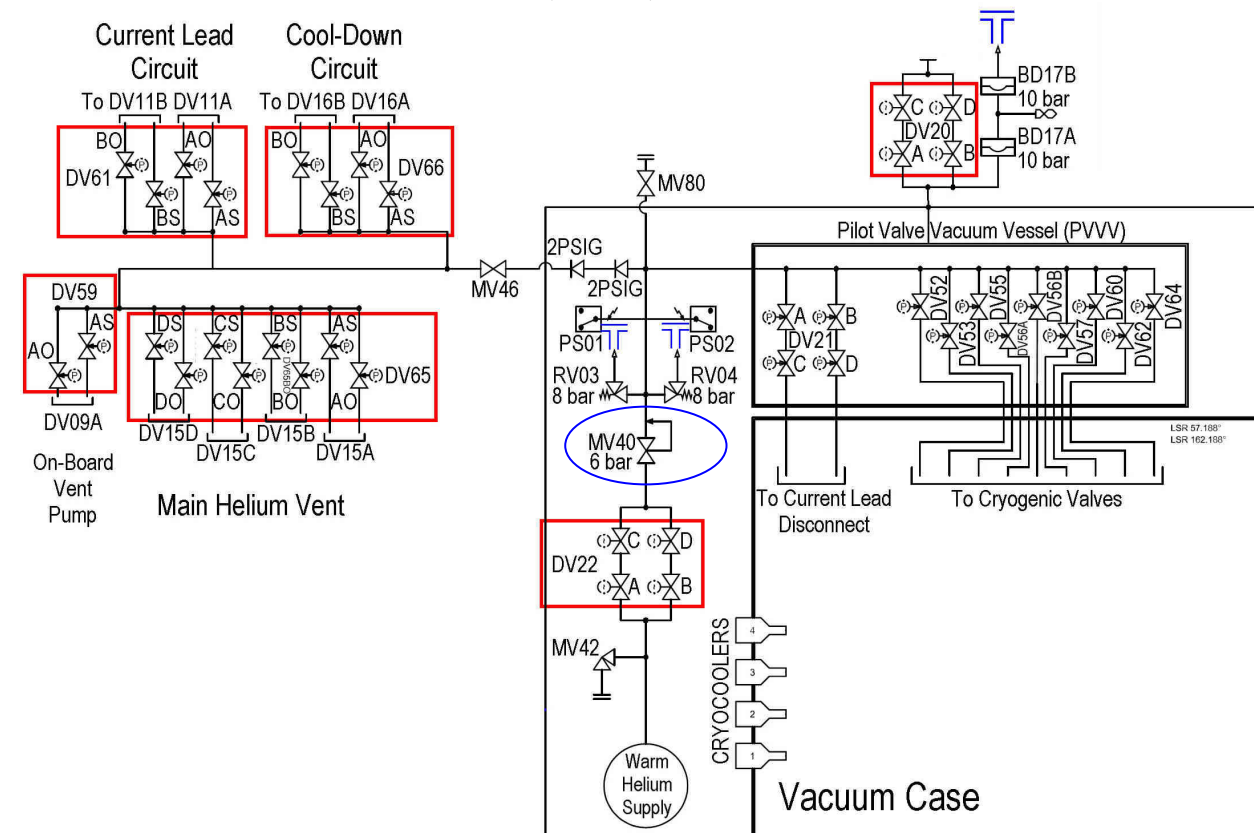
Figure A17-1 Warm Helium Gas Supply (Blue Circle indicates anomalous regulator)
